VISIONS OF BELEN

May 24, 2018

This month we are featuring an existing building that is for sale on the northwest corner of First and Becker.

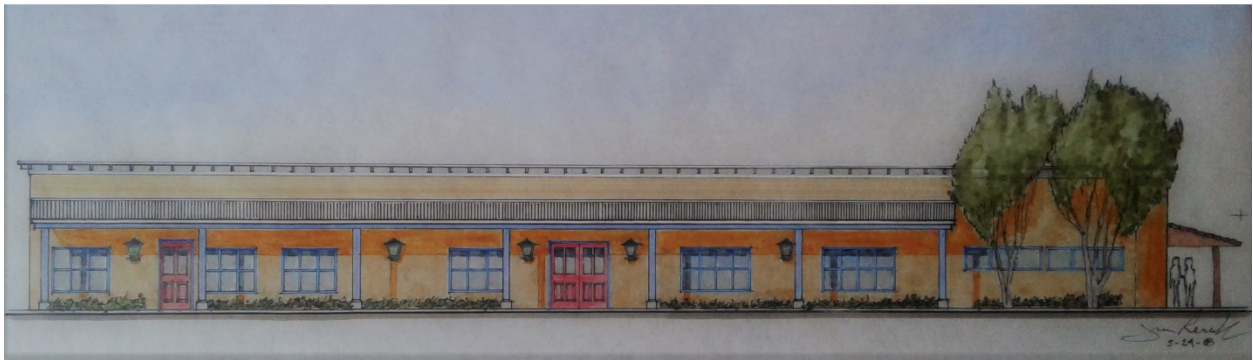
The elevation sketch below illustrates how the appearance of this building might be improved and its all in the details!

1. First of all, the columns should be replaced with larger, 8" x 8" wood columns which should be set at least 8" above the sidewalk on concrete piers so they don't sit in rain water and rot prematurely. The current 4" x 4" columns are proportionately too small and look very flimsy.
2. Remove all the aluminum siding from the building. This siding does not reflect the original history and character of Belen. It was probably a 1960's addition.
3. Replace the sidewalk cover structure and provide a more significant exposed wood framed structure with a old style corrugated metal.
4. Add a historic, appropriate cornice to the top of the parapet wall. This would make the building look very much like Paul Fiel's original 1913 building. Pictures of that building are available at the Library.
5. Replace the doors and windows and use a more turn of century (1900's) style clad wood window.

6. Since the brick is in unknown condition, I suggest covering the brick with stucco. The brick does not appear to be a highly desirable red brick so I would consider this change which is similar to early territorial style buildings found in the Belen area.
7. I would also suggest a more vibrant color scheme to liven up the area and give it a more up-scale look.
8. Provide new light fixtures. I would suggest wrought iron style fixtures of a turn of the century style.
9. And last but not least, add some LANDSCAPE PLANTING! The existing street scape is way to harsh to expect people to walk around this area in the summer time. As you know though, this harshness will be dealt with in our Great Blocks Project to talked about last month at our Breakfast Briefs at Rita's restaurant.
